# How Often Should I Clean My Solar Panels?

A practical guide to protecting performance, safety and warranty position.

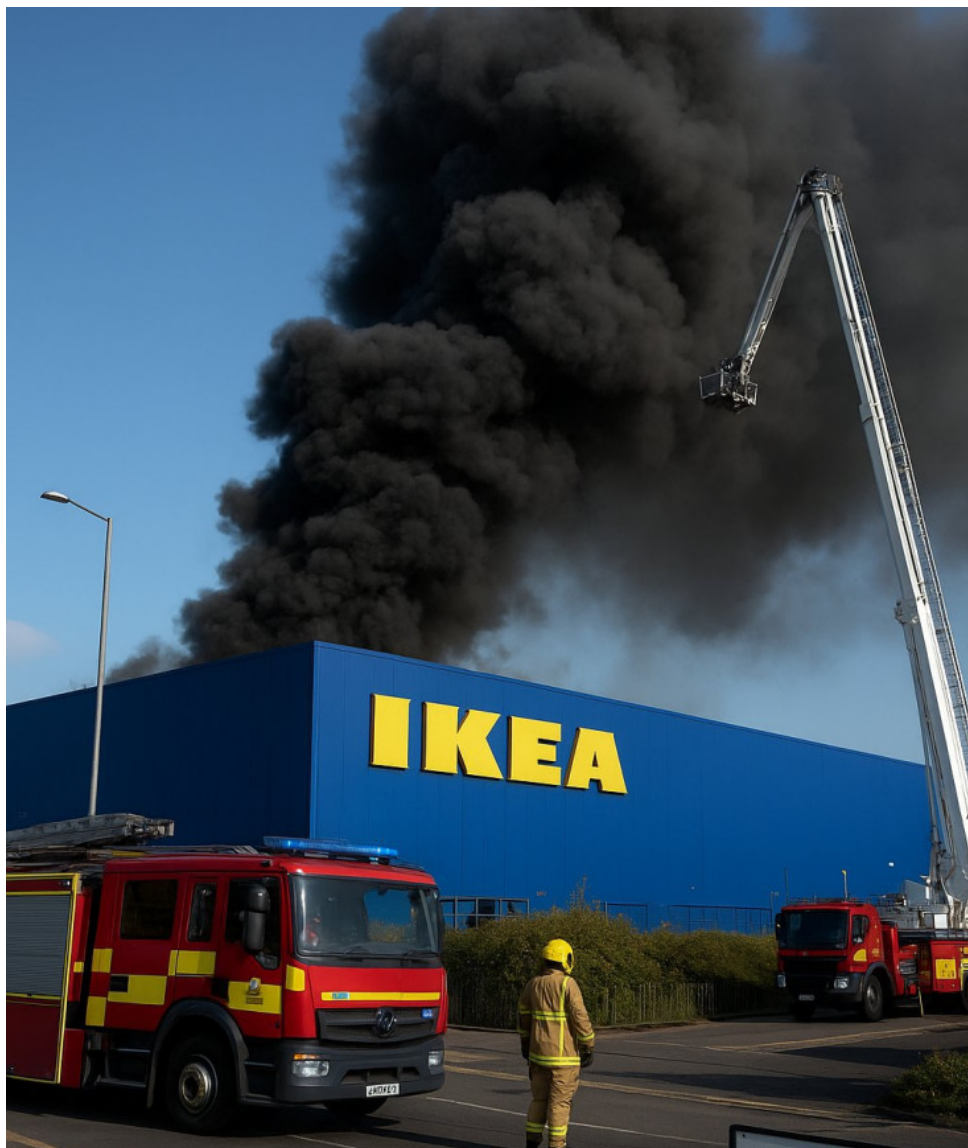
### IKEA Wembley — October 2025

Approximately 100 solar panels were alight on the roof of IKEA's Wembley store. Around 250 people were evacuated while 30 firefighters tackled the fire using five fire engines and a 32-metre turntable ladder.

Excessive electrical resistance in a connector, termination or damaged component produces heat. Depending on its location and visibility, abnormal heating may be detectable through infrared inspection before burning occurs. This makes thermography particularly valuable when combined with electrical testing of strings, connectors, isolators and inverters.

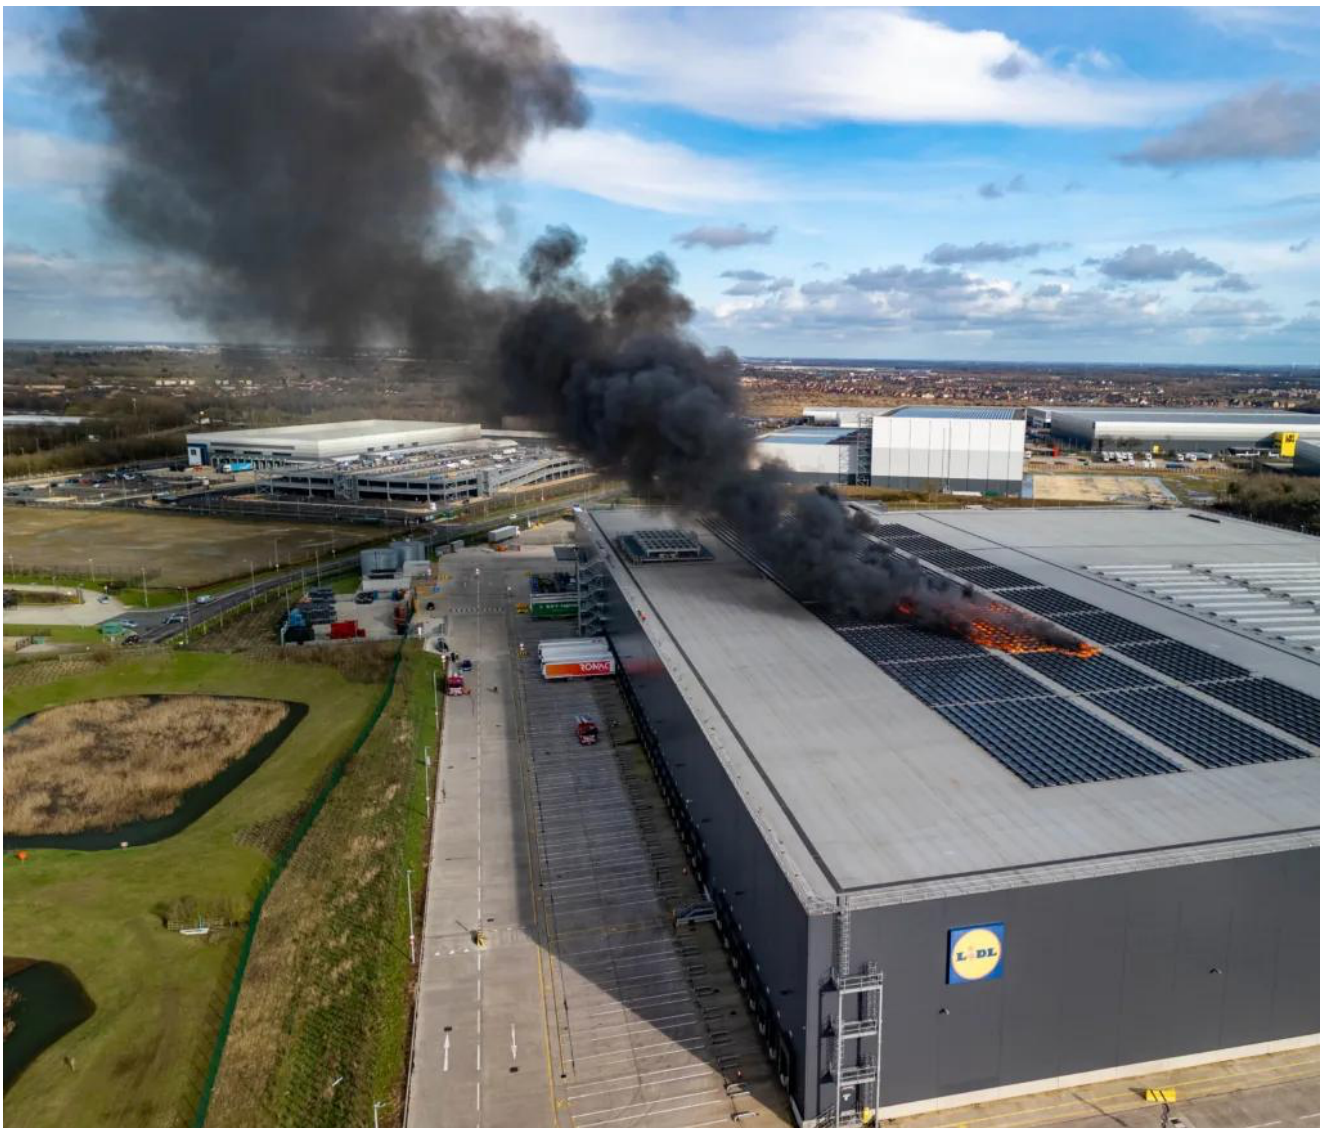
### Lidl distribution centre, Peterborough — February 2024

More than 50 firefighters attended a fire involving solar panels on the roof of Lidl's large distribution centre in Peterborough. The response required breathing apparatus, hose reels, a turntable ladder and a water carrier.

The incident illustrates the scale of the emergency response that can be required when a fault develops within a large commercial array. Regular drone surveys allow thousands of modules to be inspected efficiently, while accurate panel and string mapping can help maintenance teams isolate and investigate suspect areas before a fault escalates.

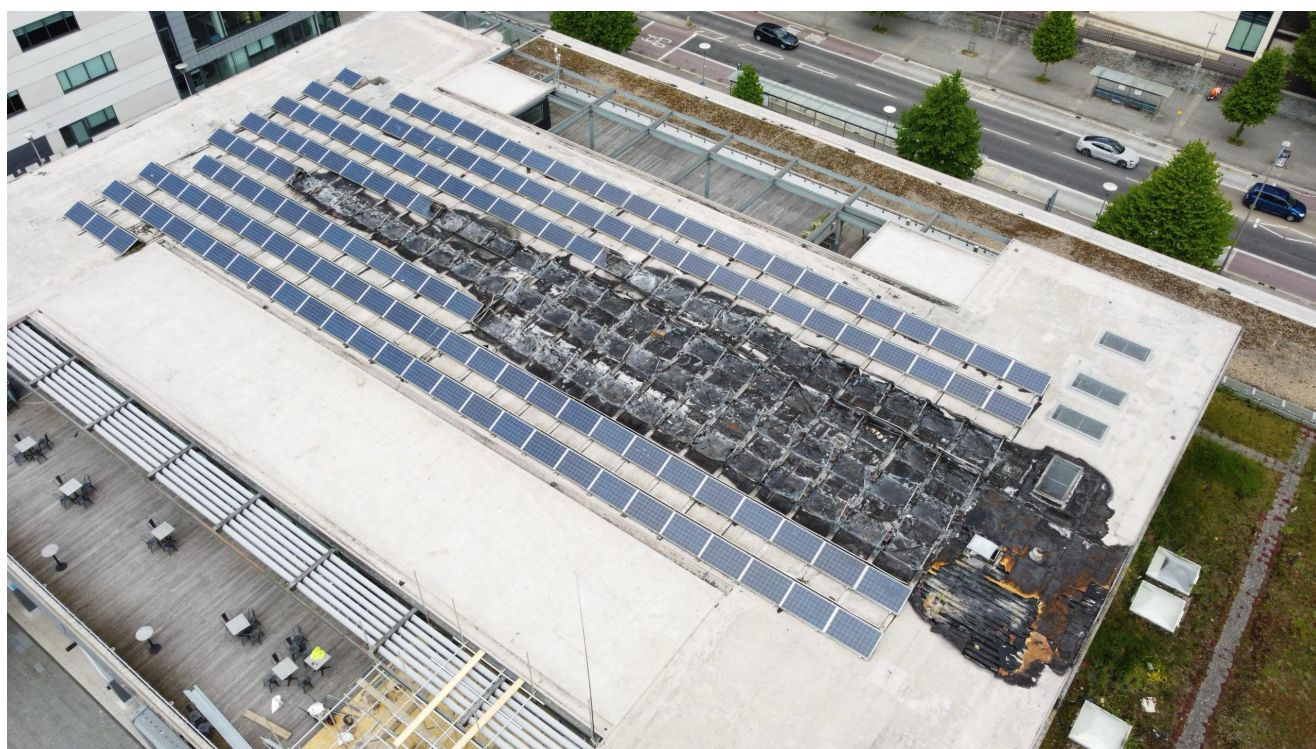
## We The Curious, Bristol — April 2022

A fire started within the rooftop solar installation at the We The Curious science centre in Bristol. Subsequent investigations indicated that birds had probably damaged part of the photovoltaic system, creating an electrical fault that allowed fire to spread to the roof.

This incident demonstrates how bird activity and damage beneath panels can develop into a serious electrical fault. Regular visual inspections, bird-control measures and cleaning can identify nesting materials and physical damage. Thermographic surveys can supplement these checks by identifying modules or circuits displaying abnormal heating while the system is operating.
